**CRITICAL DESIGN REVIEW
UH-1N HELICOPTER RESCUE HOIST**

TECHNICAL REPORT ASD-TR-73-25

JULY 1973

AERONAUTICAL SYSTEMS DIVISION
AIR FORCE SYSTEMS COMMAND
WRIGHT-PATTERSON AIR FORCE BASE, OHIO

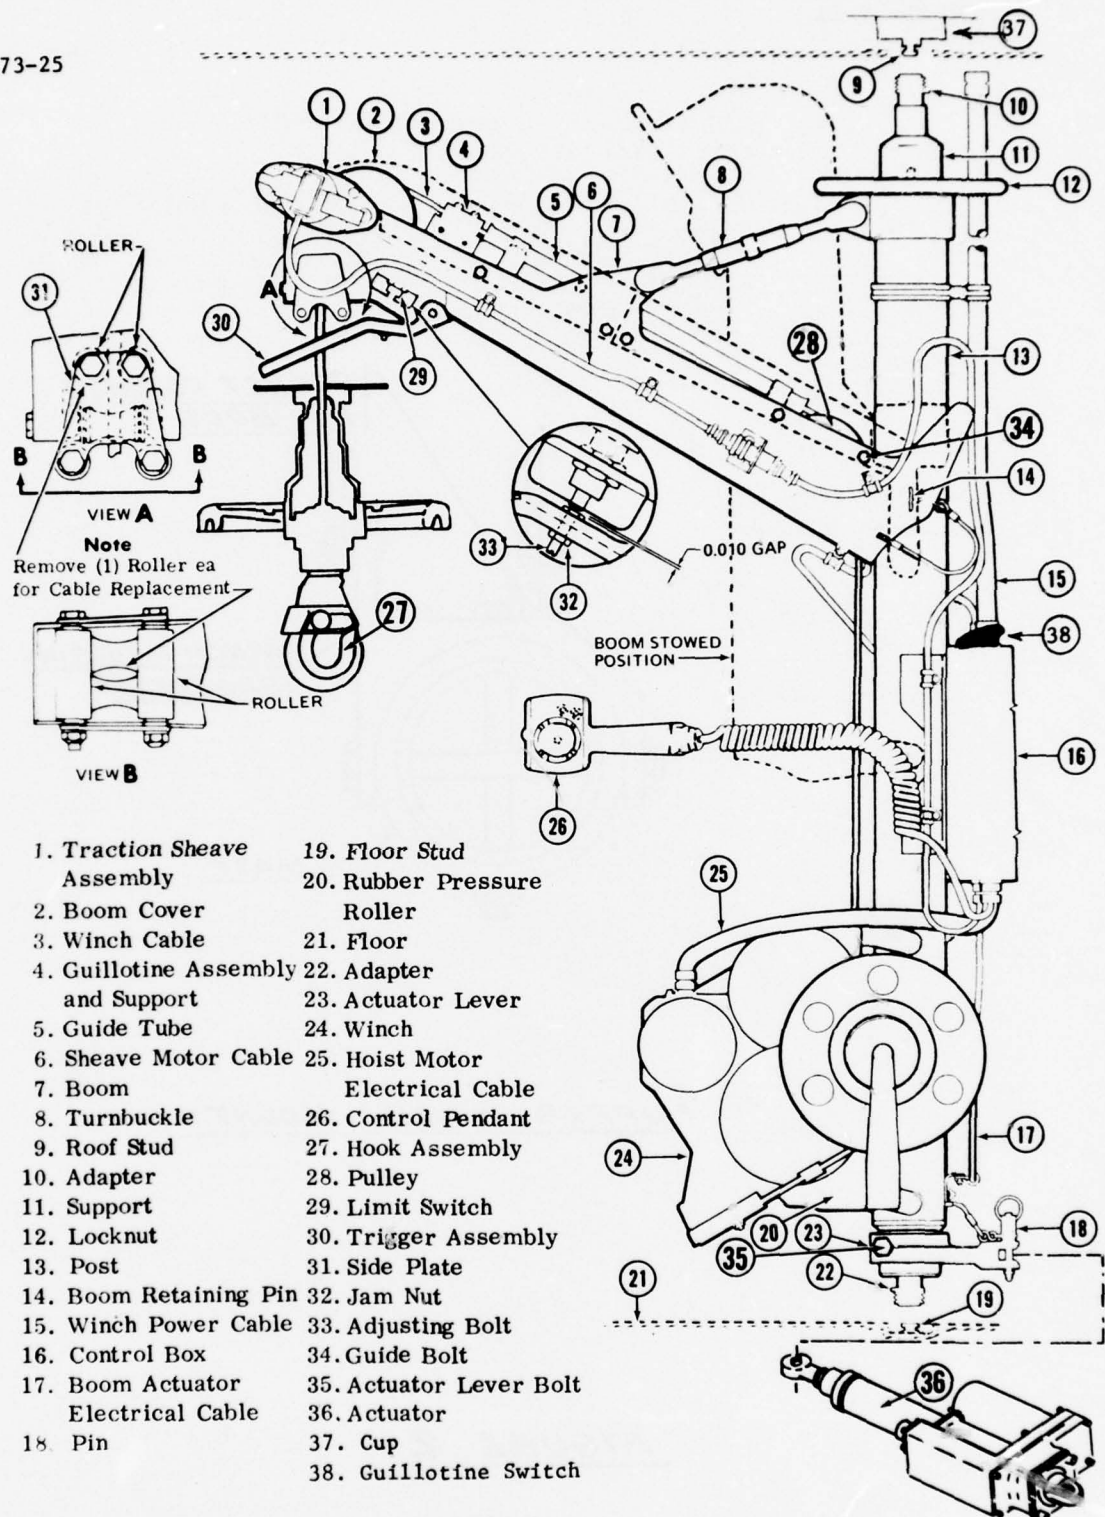
FIGURE 1

(2) Ceiling Studs - Verified reports by the user have been received to the effect that the ceiling studs (Fig 1, item 9) are loosened by continuous use. These studs are retained in ceiling mounted cups (Fig 1, item 37) by a castellated nut with washer and cotter pin. Since the nut cannot appreciably loosen, then loosening of the connection is attributed to wear in the washer and/or cup when the stud rotates. Rotational forces are induced when the mast/boom assembly is rotated in and out of the aircraft. Complete correction of this condition could be accomplished by incorporating anti-friction bearings in the mast ends. This would be an extensive hoist design change. A workable compromise might be the substitution of a larger diameter flat washer between the nut and cup. This would all but eliminate the possibility of wearing through and failing the cup, and additionally, the ceiling cups that are presently riveted in place could be bolted to facilitate initial installation and subsequent inspection. Feasibility of this change, plus other alternatives, should be investigated.

a. Ceiling Mount Studs - Users have reported that these studs become loose in service. The contractor should determine whether or not this condition could occur in all mounts and could lead to failure and cause the hoist to detach. If this could reasonably be expected to occur, then the contractor should propose a cost effective airframe (TCTO type) modification.

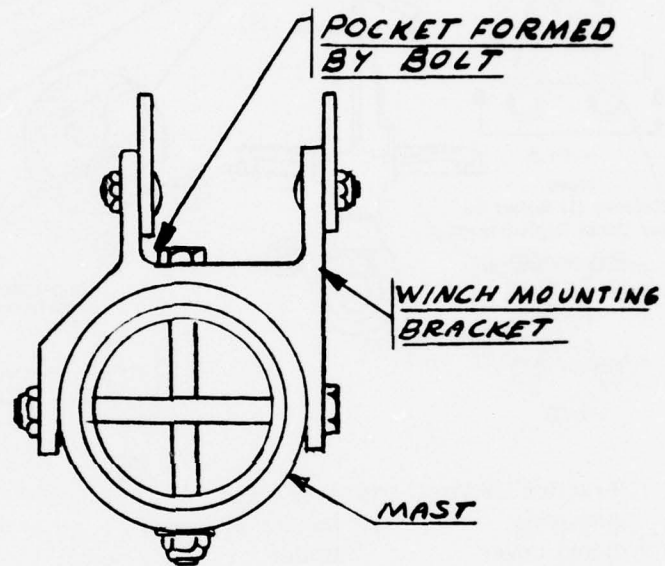
FIGURE 2

(4) Winch-to-Mast Connection - The brackets which facilitate mounting the winch on the vertical mast have been analyzed and found to be structurally adequate. It was determined, however, that a potential cable snag area is formed by a hex head bolt in the top mounting bracket (Fig 2). This condition can be corrected by substitution of an oval head machine screw.

UPPER WINCH MOUNT

(9) Upper Winch Mount - Replace the hex head bolt in the upper winch mount with an oval head machine screw to eliminate a pocket for potential cable fouling (Fig 2).

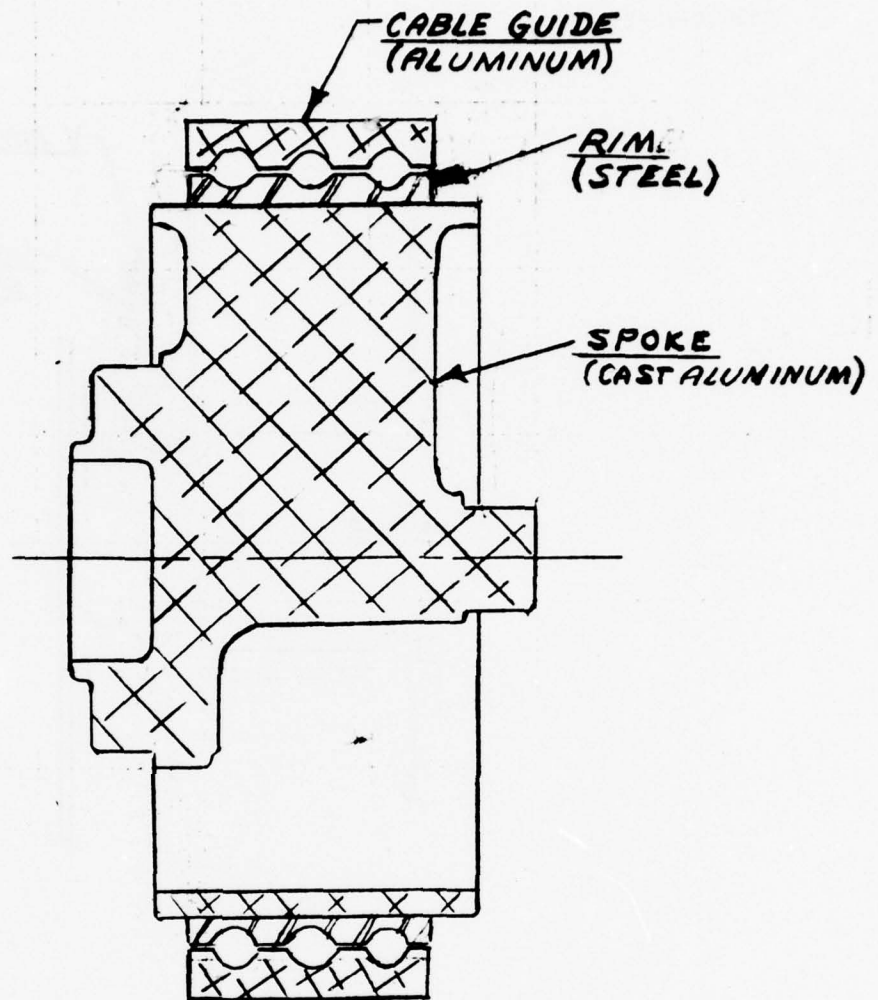
FIGURE 3

(a) Failed Spokes - At 4,000 lift cycles (last 1,400 at 600-pound load) into the cable evaluation portion of the CDR, the secondary capstan spokes failed with resulting cable failure. Suspected cause of the capstan failure was metal fatigue in the cast aluminum spokes. The hoist involved came to the CDR directly out of overhaul. Overhaul records do not record previous hoist use (cycles or hours); however, it was shown that the secondary capstan had never been replaced.

(b) Capstan Rim Slippage - At 1,551 cycles into the electro-mechanical evaluation testing (51 cycles at 600 pounds load), the cable failed. An exterior inspection of the winch was made and no cause could be determined. A new cable was installed and the cycling continued at 600 pounds load. At 1,771 cycles the cable again failed. Both cables were inspected and it was found that the inner core failed while the outer strands were still intact; i.e., there was no visible indication of damage until final failure. At this point the winch was partially disassembled and it was found that the grooved steel rim had slipped 1/16 inch axially along the cast aluminum capstan body and had forced the cable against the aluminum cable guide (Fig 3). Cable failure was attributed to the binding and pinching action between the rim and bear claw. No definite cause of rim slippage was determined. However, there were three noteworthy, associated conditions. There was a snapping noise in the secondary capstan area which started at about 1,500 cycles. Subsequent inspection revealed that the shrink fit dimensions between the rim and capstan were slightly loose and out of tolerance. Finally, both spoke failure and rim slippage occurred at 600 pounds load.

SECONDARY CAPSTAN (SECTION)

(c) Corrective Design Change - The in-house review team and Breeze Corp analyzed the failures described in (a) and (b) above. The out-of-tolerance condition was considered a possible cause for the lateral rim slippage but was discounted as a reason for spoke failure. Excessive winch bearing mount deflection was also considered as a potential cause of both the spoke failure and the rim slippage. This consideration was based on the fact that original winch qualification (endurance cycling at high load) was conducted at Breeze Corp with the winch mounted on a relatively massive test fixture. The CDR testing was conducted with the winch mounted on the relatively flexible mast. It was agreed that verification of such a theory would require additional extensive testing. The correction that appeared most promising was incorporation of a steel capstan of heavier section than the present cast aluminum/steel design.

(2) Secondary Capstan - Incorporate a steel secondary capstan in the winch to replace the existing aluminum and steel unit (Breeze P/N BL-5164). Configure the grooved surface so that the need for a side spacer (P/N BL-8079) is eliminated.

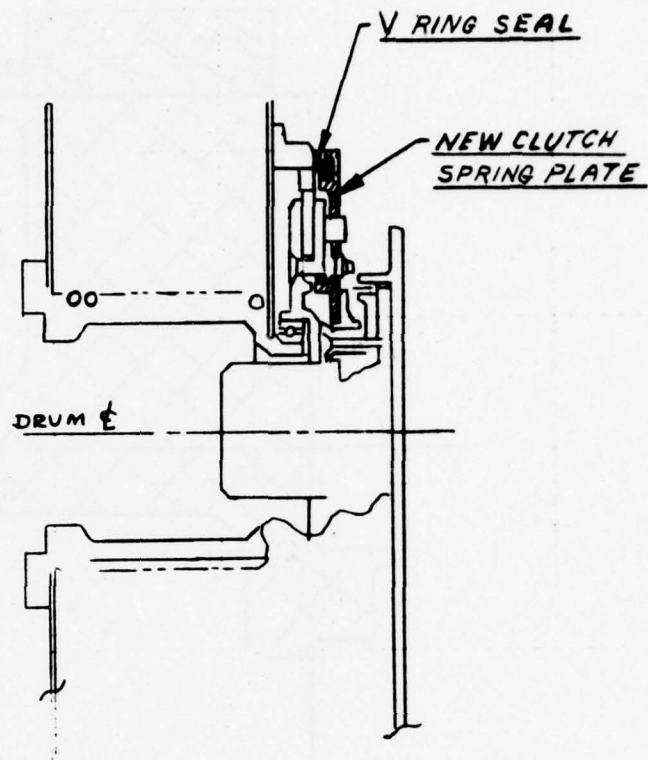
FIGURE 4

(a) Cable Spooling - When foreign material, such as water or grease, infiltrate the clutch area, the tensioning function of the clutch deteriorates to the point where the cable spools on the storage drum. This spooled cable can, and does, loop over the drum flange and fouls/binds when cable is subsequently payed out. This binding action creates excessive tension which finally severs the cable. Entry of foreign material can be stopped by installing a permanent clutch area seal (Fig 4).

STORAGE DRUM CLUTCH SEAL (SECTION)

WARNING: Care should be used to insure that no oil or water is introduced into the storage drum clutch area.

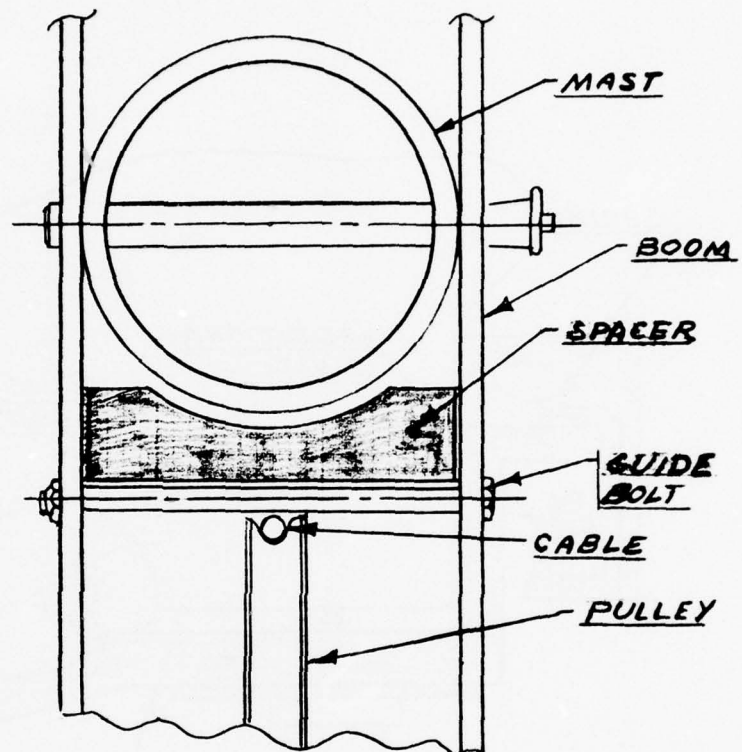
FIGURE 5

(2) Pulley - Although smaller than recommended by cable manufacturers for optimum cable life, the inboard boom pulley (Fig 1, item 28) is considered adequate in structure and cable interface. The adequacy is, however, dependent on cable replacement within prescribed intervals. With regard to installing a new cable on the hoist, there is a configuration in this area that has led to a misreeved and subsequently failed cable. The cable guide bolt (Fig 1, item 34) is located so that cable can be reeved over the bolt rather than properly between the bolt and pulley. The potential for misreeving could be greatly reduced by incorporating a spacer to block out the area between the bolt and the mast. The area in question and spacer configuration are schematically depicted in Fig 5.

SPACER TO PREVENT MISREEVING

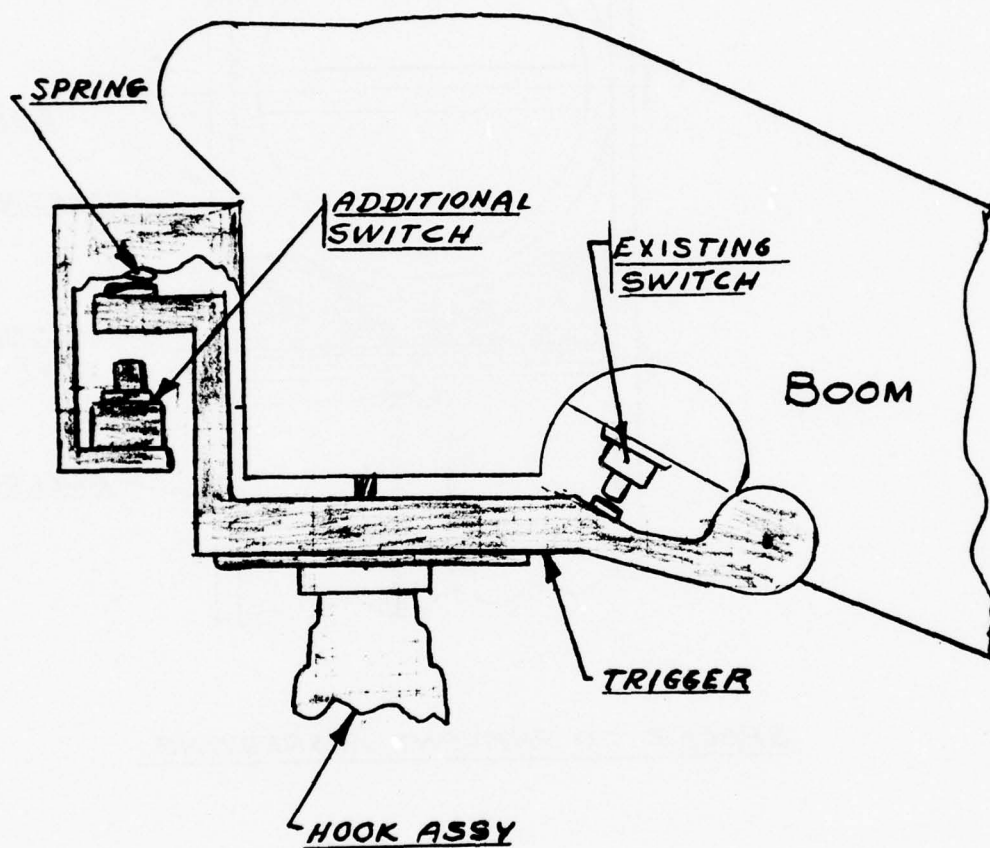
FIGURE 6

1. Adjustment - As the adjusting bolt is backed off, the two block force (tension in the cable caused by powering the hook assembly against the boom) becomes progressively higher. This force reaches approximately 3,000 pounds when clearance between the adjusting bolt and switch is such that the hook assembly contacts the rollers (Fig 1, view B) prior to switch activation. Considering that the cable's ultimate strength is 3,300 pounds, failure in the cable can be expected at any time there is a gross misadjustment (manually set or through vibration) or malfunction in this area.

2. Electric Short - If the limit switch shorts in the closed position and plunger activation does not open the series circuit to the motor power relay, two block forces will reach 2,800 pounds. Cable failure in this case will again be imminent.

3. Trigger Deformation - Another potential cause of excessive two block forces is permanent deformation in the trigger structure. Such deformation would allow the bumper assembly to contact the boom mounted rollers prior to limit switch activation.

UP LIMIT SWITCH

(c) Corrective Design Change - Considering the above, it is apparent that a rather extensive up limit switch assembly redesign is required to insure near fail safe performance. A design of this type would incorporate full redundant electrical circuitry, would not be adjustable in the field, and would have rugged construction to resist deformation. One such design is schematically depicted in Fig 6.

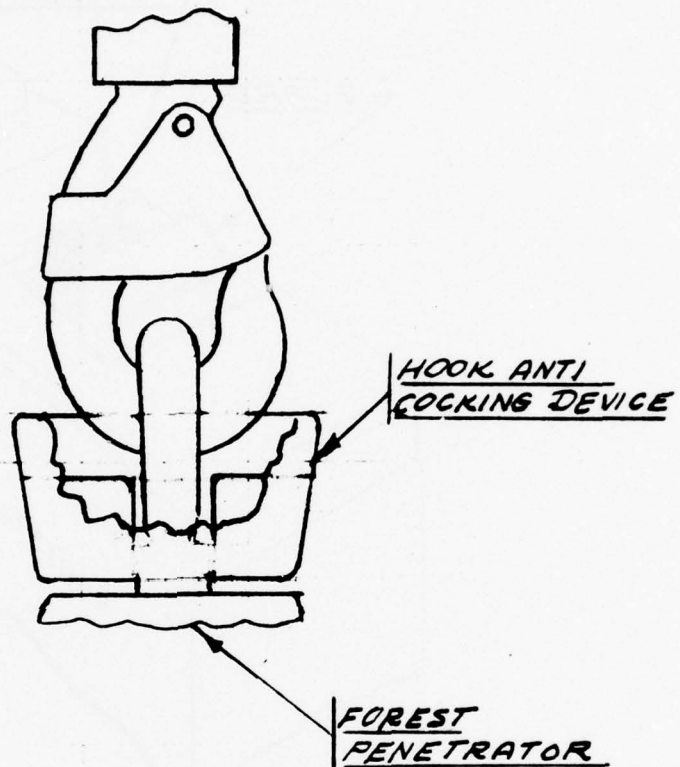
FIGURE 7

ANTI COCKING DEVICE

(7) Hook Anti-Cocking Device - Provide hook anti-cocking devices for use with the forest penetrator (Fig 7). This device will reduce an adverse cable loading condition caused by a sharp bend at the ball end fitting.

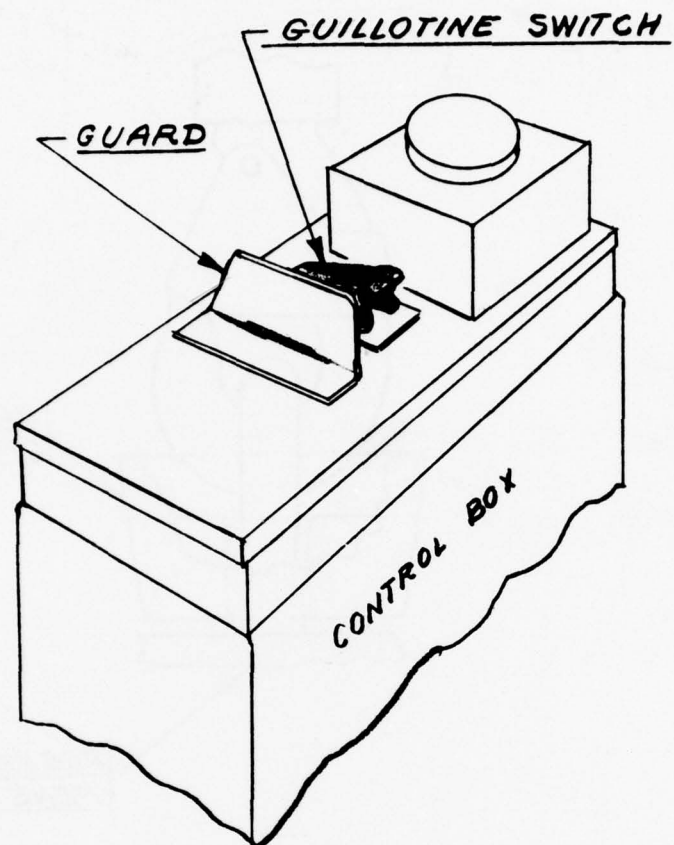
FIGURE 8

(4) Guillotine - The guillotine assembly proper (Fig 1, item 4) is considered adequate. There is, however, a potential problem in its activating switch located on the electric control box. The existing switch and safety cover actuate in the same direction of rotation. This means that a single motion, single direction, manual manipulation could expose and activate the switch. Such a configuration in the present location is susceptible to inadvertent actuation. Incorporating a switch guard (Fig 8) would greatly reduce this hazard.

GUILLotine SWITCH GUARD

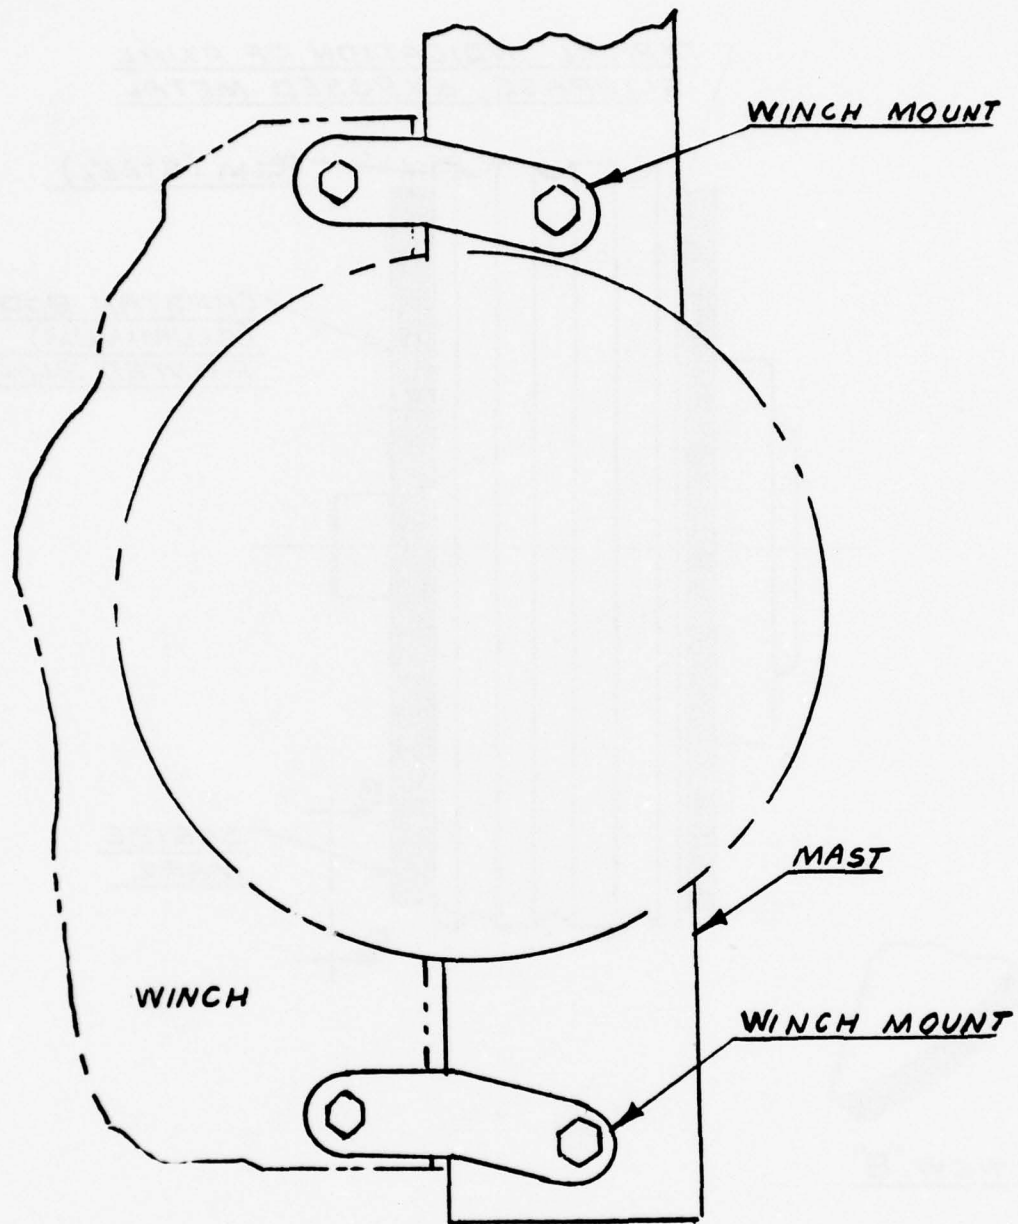
FIGURE 9

b. Winch Mounting - The winch manufacturer considers it a distinct possibility that secondary capstan fatigue failure may be caused by excessive displacement of one winch mount (Fig 9) with respect to the other, and that mast deflection would cause this displacement. With this in view, it is recommended that the contractor investigate the feasibility of incorporating a single "strong back" mount to reduce displacement.

EXISTING WINCH MOUNT
CONFIGURATION
